Manhole Inspection Summary

Manhole # S69M__006MH

Insp Date: **1/29/08 8:43 AM**

Location Address: **6700 Graceland Ave.**

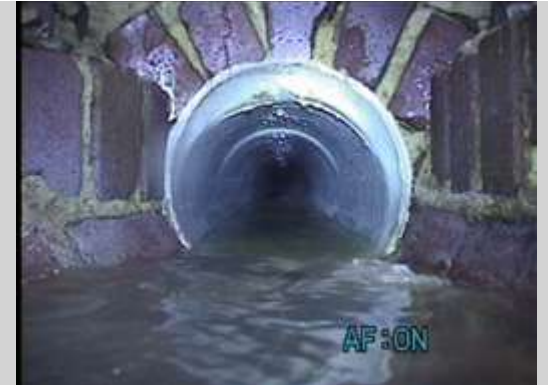
12 O'Clock Outflow

8 in. Circular Gravity Sewer
Pipe Out @ 12 O'Clock

Pipe Height: **8.4** (in.) Rod and Bar (Angled)
Pipe Material: **Clay** ☐ Pipe Lined
Invert Depth: **8.29** (ft.) Flow Characteristics: **Slow**
Deposits: ☒ None ☐ Mud ☐ Sludge ☐ **Debris** ☐ Grease
Silt Depth: (in.) Deposits Extent:
Infiltration: **None** Pipe Seal Cond: **Sound**

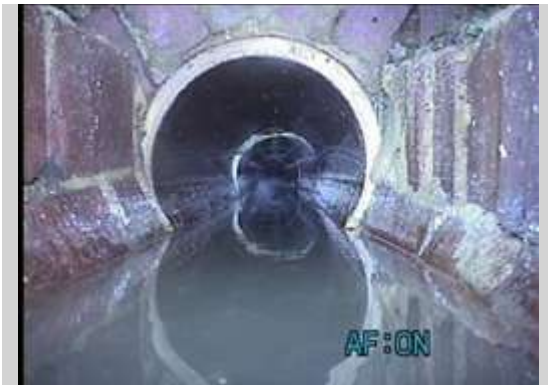
6 O'Clock Inflow

8 in. Circular Gravity Sewer
Pipe In @ 6 O'Clock

Pipe Height: **8.4** (in.) Rod and Bar (Angled)
Pipe Material: **Clay** ☒ Pipe Lined
Invert Depth: **8.21** (ft.) Flow Characteristics: **Slow**
Deposits: ☒ None ☐ Mud ☐ Sludge ☐ **Debris** ☐ Grease
Silt Depth: (in.) Deposits Extent:
Infiltration: **None** Pipe Seal Cond: **Sound**

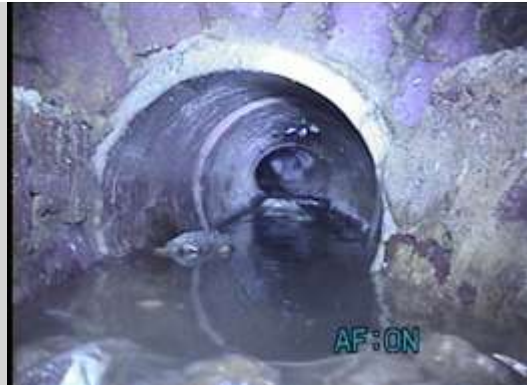
8 O'Clock Inflow

Deposits: ☐ None ☐ Mud ☐ Sludge ☒ **Debris** ☐ Grease

Silt Depth: **1** (in.) Deposits Extent: **Medium**

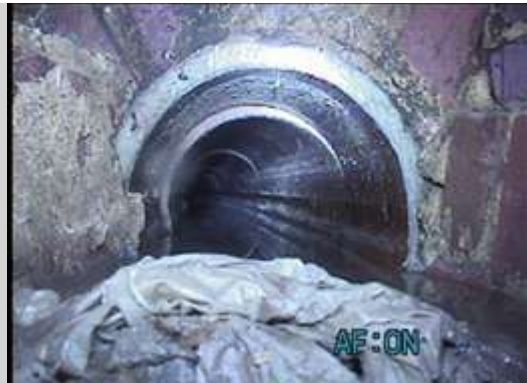
10 O'Clock Inflow

Deposits: ☐ None ☐ Mud ☐ Sludge ☒ **Debris** ☐ Grease

Silt Depth: **1** (in.) Deposits Extent: **Medium**
